Topographic and Geological Features Involved in Water Leakage at Levee Foundations and in Levee Body Deformation by Piping on the Kakehashi River

Yutaka SATO

Shoji FUKUOKA

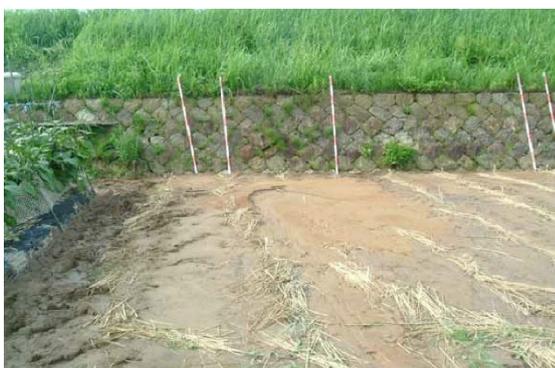
Photo 1. Water leakage (with sand boil) in the Shirae district (KP6.6 on the left bank) (MLIT, 2007)

In the Shirae district (KP6.6 on the left bank) shown in Photo 1, sand boils took place near the toe of the levee landside slope and in crop fields protected by the levee. Flood-fighting activities were conducted in that district by “hooping.” In this method, sandbags are piled up in a semi-circular arrangement to prevent the spread of water leakage when water begins to leak at the back of the levee. In the Arakida district (KP9.5 on the left bank) shown in Photo 2, water leakage occurred in paddy fields protected by the levee. There were no sand boils, as shown in the enlarged photo. Figure 1 shows a distribution map of the former river channels which were identified by using U.S. military aerial photos taken after the Pacific War and survey maps of 1902 created by the Kanazawa Construction Office of the former Ministry of Construction. In the Shirae, Sendai, Kofu, and Arakida districts, where water leakage at the levee foundation occurred, the water leaked near where the levee crossed the former river channel and in areas bordered by the former river channel and the levee.

Judging from the particle size composition, the boiling sand in the Shirae district was sand distributed in the surface layer (Photo 1). The coefficient of uniformity of that sand is 10 or less, and the fine fraction content is 35% or lower. Values greater than these indicate a high likelihood of liquefaction, according to the Specifications for Highway Bridges (Japan Road Association, 2012). Water leakage alone took place in the Sendai district. The surface layer consists of silt and sand, and the fine fraction content is 50%. The boiling sand in the Kofu district (Photos 3 and 4) is sand distributed in the surface layer, as in the case of the Shirae district. The surface layer in the Arakida district consists of cohesive soil. Consequently, there were no sand boils, and only water leakage occurred (Photo 2). A grading curve of the permeable layer that makes up a gravel bed is shown in Figure 11. This curve is on the right of the grading curve of boiling sand. The coefficient of uniformity is 44, which is quite high, and the curve is gentle.

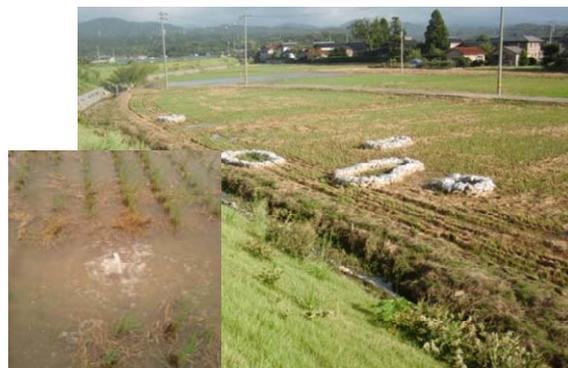
Photo 2. Water leakage in the Arakida district (KP9.5 on the left bank) (MLIT, 2014)

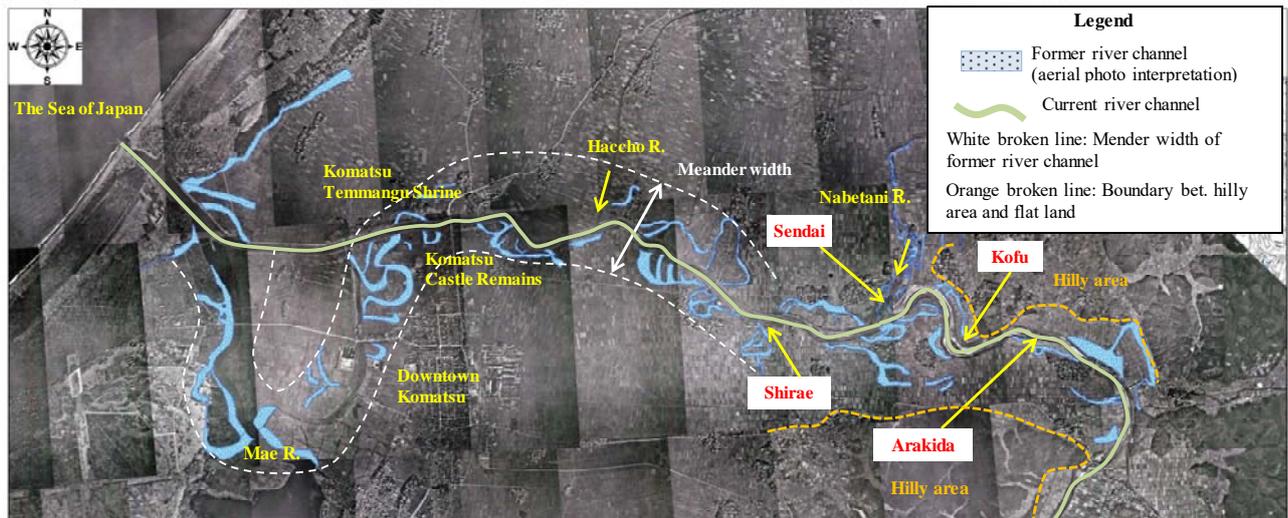
The basin at the lower reaches of the Kakehashi River has long been a damp area, and it has frequently flooded. In 1869, the section of the Kakehashi River between the Haccho River and the Nabetani River was straightened by the cutting off of large meander river channels. From 1911 through 1923, the Kakehashi River was improved by the cutting off of a large southward meander river channel downstream of Komatsu Castle and the shortening of the river channel there into a 1.1km-long section. The aerial photos taken by the U.S. military after the war show that most of the former river channels had been converted to paddy fields. The bed slope gradient of the former river channel between the river mouth and the Kakehashi River’s confluence with the Nabetani River is 1/4,500. The former river channel was serpentine, and the meander belt had a constant amplitude. The former river channel was joined by the Haccho River, largely bent southward near Komatsu Temmangu Shrine, and was joined by the Mae River before flowing into the Sea of Japan. In the former river section upstream of the Nabetani River, the meander amplitude was smaller than at the lower reaches, and the meander width was restricted by the surrounding hills. Water leakage at the levee foundation occurred immediately upstream and

downstream of the Kakehashi River's confluence with the Nabetani River. The bed slope gradient changes at the confluence.

Figure 1. The former river channels of the Kakehashi River identified in U.S. military aerial photos, and places of water leakage (MLIT, 2008)

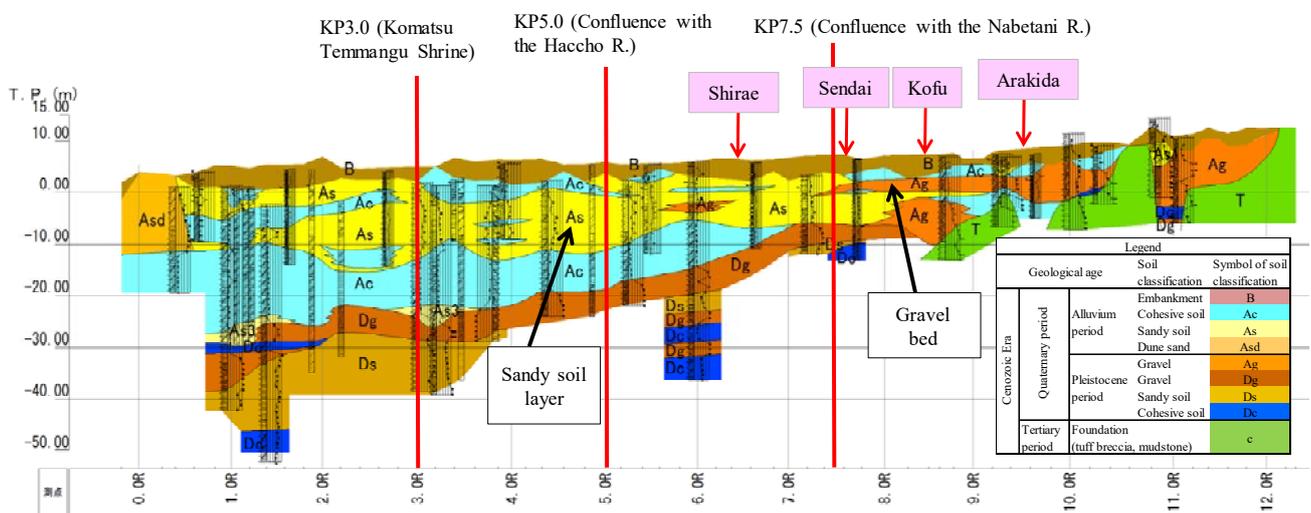
Figure 2 shows the longitudinal geological profile along the levee on the right bank of the Kakehashi River. The surface-layer soil distribution characteristics reflect the topographic features. Sandy soil is distributed from near the ground surface in the area downstream of the place near Kokatsu Temmangu Shrine where the Kakehashi River bends southward. In the area upstream of the shrine toward the Haccho River, there is a thick layer of cohesive soil near the ground surface, and the cultivated land in that area is used for paddy fields. In the river section between the Haccho River and the Nabetani River, the former channel of the Kakehashi River meanders widely, and natural levees were developed along the former channel. On that river section, sandy soil is chiefly distributed in the surface layer. In the river section upstream of the confluence with the Nabetani River, where the bed slope gradient changes, the meander amplitude of the former channel is smaller than at the lower reaches and gravel is distributed in the surface layer. Water leakage took place on the river section upstream of the Haccho River. On that section, a bed of highly permeable gravel is distributed in the foundation layer. The geology of the foundation ground in the Kakehashi River can be summarized as follows: Gravel is chiefly distributed at the upper reaches, with the particle size decreasing toward the lower reaches, where sand is chiefly distributed. The transition of soil layers follows the sediment deposition of rivers.

Figure 2. Longitudinal geological profile along the levee on the right bank of the Kakehashi River (MLIT, 2014)

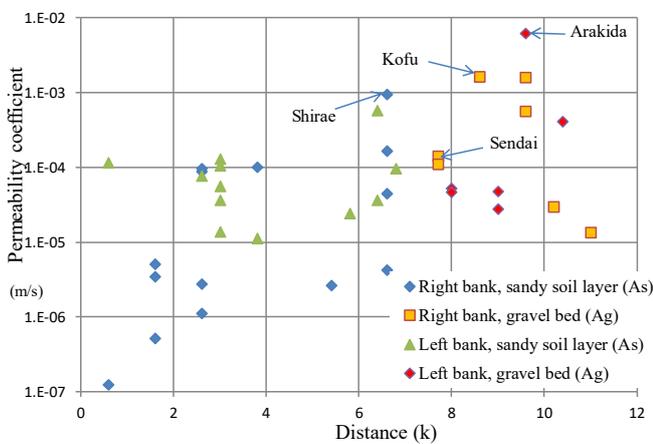
Regarding the permeable layer (sand or gravel), which is a causal factor in water leakage at the levee foundation, Figure 3 shows the relationship between the distance from the river mouth (the x-axis) and k of the permeable layer (the y-axis). The value of k tends to decrease toward the lower reaches and to increase toward the upper reaches, consistent with the geological layers shown in the longitudinal geological profile.

The datum in the black square in Figure 3 is the value for homogeneous dune sand, and the order of k is 10^{-4} m/s. The data in the blue square in Figure 3 are k of the gravel layer deposited in the valley bottom plain, and the orders of the values of k are 10^{-4} ~ 10^{-5} m/s. The sediment in the valley bottom plain consists of soil from the surrounding mountains, and the matrix of the gravel layer has a high content of fine-grained fraction. Thus, the values of k are low.

Figure 3. Permeability coefficient of the permeable layer in the foundation ground in the river longitudinal direction

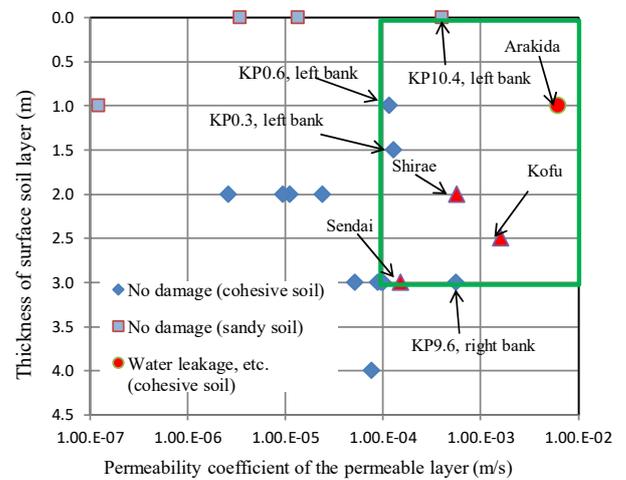
By using the cross-sectional geological profile (MLIT, 2014) created on the basis of detailed surveys of the levee, the diagrams shown in Figure 4 were developed. These diagrams show the thickness of the surface layer near the toe of the levee landside slope on the right bank and k of the permeable layers below the surface layer. The thickness of the surface layer and k are factors that directly affect the occurrence of piping. The permeable layers are ‘As’ layers and ‘Ag’ layers, which are continuously distributed from the river mouth to KP10.5 in Figure 2. Based on these diagrams, Figure 5 shows the relationship between k of the permeable layer (the x-axis) and the thickness of the surface layer (the y-axis). Figure 5 indicates that water leakage occurred at places where cohesive soil is distributed near the ground surface, the surface layer is 1~3m thick, and the k of the permeable layer is at least 10^{-4} m/s. Water leakage did not occur in the region within the green square in Figure 5. The region contains a sand dune and a valley bottom plain. Regarding the places where water leakage occurred, causal relationships between water leakage and factors such as a change in the bed slope gradient and topographic features (such as the former river channel) need to be analyzed.

Figure 5. Relationship between the permeability coefficient of the permeable layer and the thickness of the surface layer

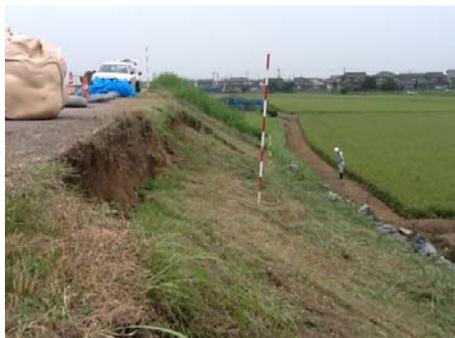
Figure 6 shows the locations of water leakage due to the flood in the Kofu district in July 2013 and the distribution of the former river channels. Photo 3 shows KP8.4, where sliding failure occurred at the levee due to water leakage at the levee foundation. Sand boils also occurred in the area protected by the levee. At KP8.6, sand boils occurred and the levee crown cracked (Photo 4). Sand boils also occurred at KP8.2. The soil properties and the levee conditions at these sites are summarized in Tables 2 and 3. Table 2 shows the following: levee height (H); gradient of the levee landside slope (gradient of the line connecting the shoulder and the toe of the slope); piping value, G/W, calculated on the basis of non-stationary saturated and unsaturated seepage analysis that utilizes external forces of rainfall and the record of river water level (MLIT, 2014) and on the basis of stability calculation (the total stress method); safety factor against circular failure on the landside slope (Fs)(Japan Institute of Country-ology and Engineering, 2012); and disaster type.

Photo 3. Site of sliding failure near KP8.4 on the right bank (MLIT, 2014)

In the levee body deformation at KP8.4 on the right bank, the canal at the foot of the levee near the toe of the landside slope moved horizontally and upward. The soil of the foundation ground seems to have moved, too. Because water was retained in the canal at the foot of the levee upstream of where the levee collapsed, it is likely that the collapse occurred when the inland water level decreased to ground level around the canal. Sand boils occurred in a footpath between paddies, followed by sliding failure. A portable cone penetration test conducted after the levee failure (Figure9.) indicates that part of the sand layer in the foundation ground is relatively weak. Because the location, shape and the dimensions of the weak part are consistent with those of the calculated circular sliding surface, it is possible that the sliding failure was due to a decrease in the effective stress caused by an increase in hydrostatic pressure. At the same time, because the gabion walls sank significantly, the levee body deformation might have been caused by subsidence that followed the hollowing of the foundation ground due to piping and the movement of soil particles, as were simulated in model experiments by Ueno et al., (2017) and Sasaoka et al., (2017).

At KP8.4 on the right bank where sliding failure occurred, the levee was higher and the landside slope gradient was steeper than at other sites. Consequently, the safety factor against circular failure was lower than at the other sites, being close to 1.

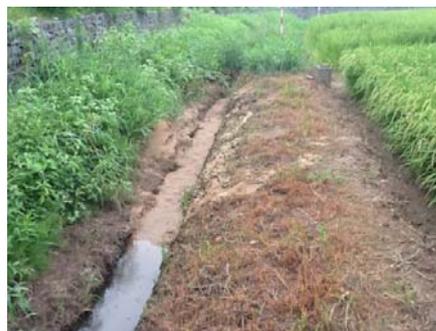
Photo 4. Sand boils near KP8.6 on the right bank (MLIT, 2007)

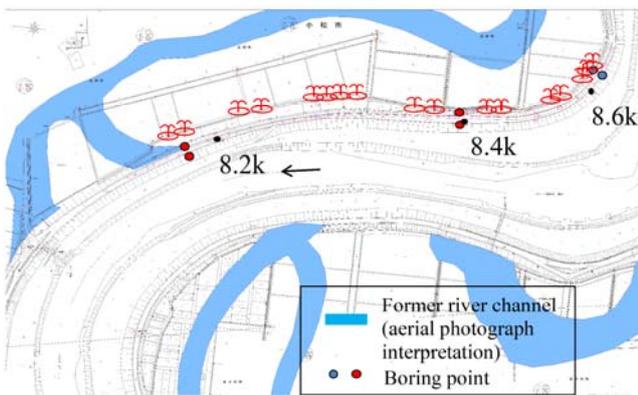
Figure 6. Site of water leakage in the Kofu district (MLIT, 2014)

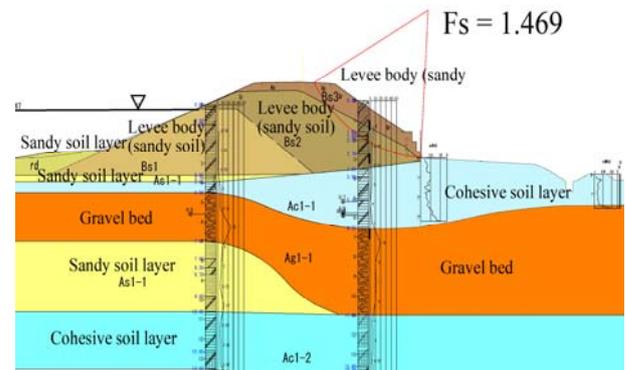
Because KP8.2 on the right bank is close to where the bank merges with the former river channel, the soil properties are the same as those of the former river channel. Near the toe of the levee landside slope, a cohesive soil layer with a thickness of up to 3.5m is distributed. At the same place, the piping value (G/W=3.178) is higher than 1. Water leakage did not occur at the toe of the landside slope. The water leakage and sand boils that occurred in the paddy fields protected by the levee were probably a result of the cohesive soil layer there being thin. The minimum safety factor against circular failure (Fs) is 1.469, a value higher than at other sites, and levee body deformation did not occur at this site (Figure 7.)

Figure 7. Geological profile at KP8.2 on the right bank (MLIT, 2014)

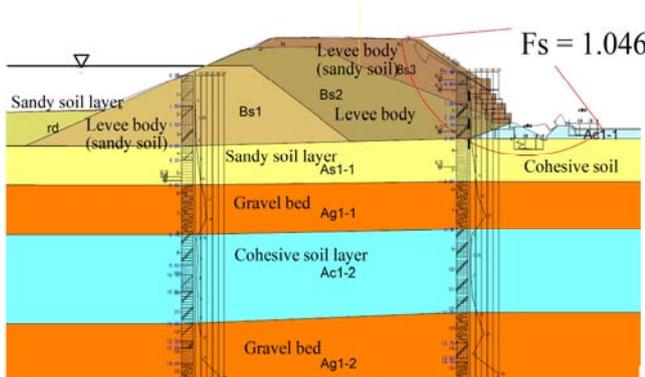
At KP8.4 on the right bank, sand boils occurred in a footpath between rice paddies. The cause is likely to have been the reduction in the inland water levels near the inside of the levee. At this site, the cohesive soil layer in the surface layer is 0.5m thick, which is thinner than at other sites, and the piping value is 0.233, which is much

lower than 1. The sand layer beneath the cohesive soil layer is up to 2m thick. The circular sliding surface given by the calculation of the minimum safety factor extends through the sand layer. The minimum safety factor is 1.046, which is higher than 1; thus, sliding failure did not occur (Figure 8.)

Figure 8. Geological profile at KP8.4 on the right bank (MLIT, 2014)

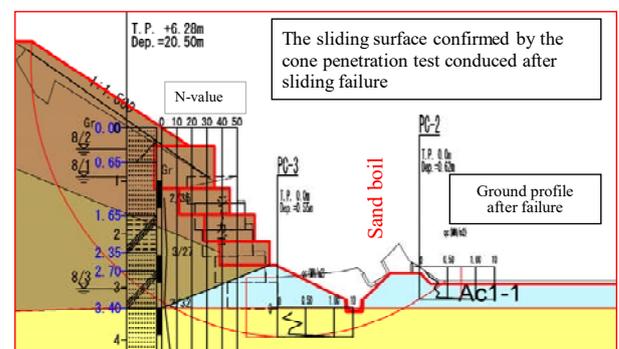
Figure 9. Portable cone test results for KP8.4 on the right bank (MLIT, 2014)

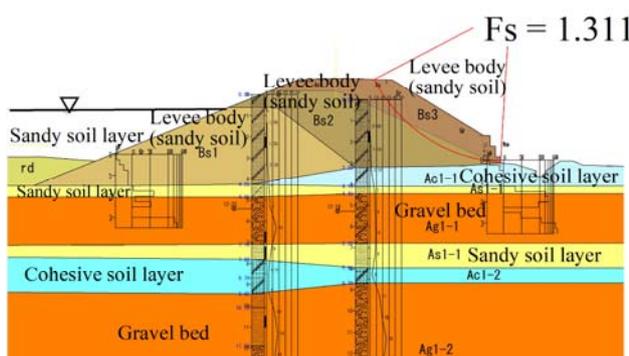
Figure 10. Geological profile at KP8.6 on the right bank (MLIT, 2014)

At KP8.6 on the right bank, large-scale sand boils occurred in the canal at the foot of the levee near the toe of the landside slope, but sliding failure of the levee did not occur. At this site, the cohesive soil layer in the surface layer was as thin as 1.0m, and the piping value was 0.438, a value higher than at KP8.4. There was no relationship between the sand boils and the piping value. The minimum safety factor against circular failure is as high as 1.311. The circular sliding path given by the calculation of the minimum safety factor extended through the levee body (Figure 10.) Sand particles but no gravel particles spurted to the ground surface; thus, it is likely that the soil particles moved in the sand layer on the gravel bed. Even when the strength of the sand layer decreases because of failure due to piping (on the assumption that the angle of shear resistance $\phi=0$), the safety factor is 1.149. A safety factor higher than 1 means that sliding failure does not occur.

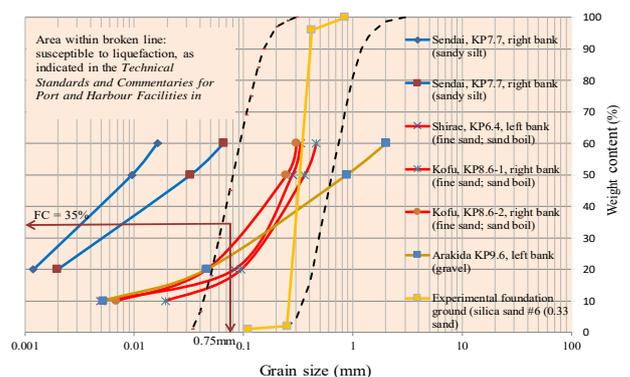
Figure 11. Grading curves for the soil of sand boil sites

Figure 11 shows the particle size composition of the sand layer where sand boils occurred (or where soil particles moved). The particle size composition is based on the soil test data from Results of Soil Tests at River Levees (River Division, National Institute for Land and Infrastructure Management, 2012). According to the Japanese Geotechnical Society, the coefficient of uniformity is D_{60}/D_{10} , but because D_{10} cannot always be obtained in soil that is high in fine fraction content, D_{60}/D_{20} was used in this study.

In Figure 11, the area between the two broken lines corresponds to a range of particle sizes that are especially susceptible to liquefaction, as indicated in the Technical Standards and Commentaries for Port and Harbour Facilities in Japan (The Overseas Coastal Area Development Institute of Japan, 2008). This suggests that the type of soil that is prone to sand boils due to piping has the same range of particle sizes as the type of sand that is likely to undergo liquefaction.

Figure 11 also shows a grading curve for the type of soil used by Ueno et al., (2017) in a model experiment. The grading of the silica sand #6 (0.33mm) used in the upper layer of the foundation ground of the model experiment is similar to the grading of sand ejected at the sand boils on the Kakehashi River. From the model experiment, it was reported that when the upper layer and lower layer of the foundation ground were made the silica sand #6 and silica sand #3, respectively, and a levee was built with bentonite-mixed soil (an impermeable material with $k=4.1 \times 10^{-9}$), not only was the sand in the foundation ground discharged, but so were portions of the soil in the bentonite-mixed levee body, and that rapid subsidence caused the levee body to collapse.
