CHANGES IN RIVER BED AROUND THE FUKAWA CONTRACTION AREA BY FLOODS AND CHANNEL IMPROVEMENT WORKS IN THE LOWER TONE RIVER

Naoki IWAYA¹ and Shoji FUKUOKA²

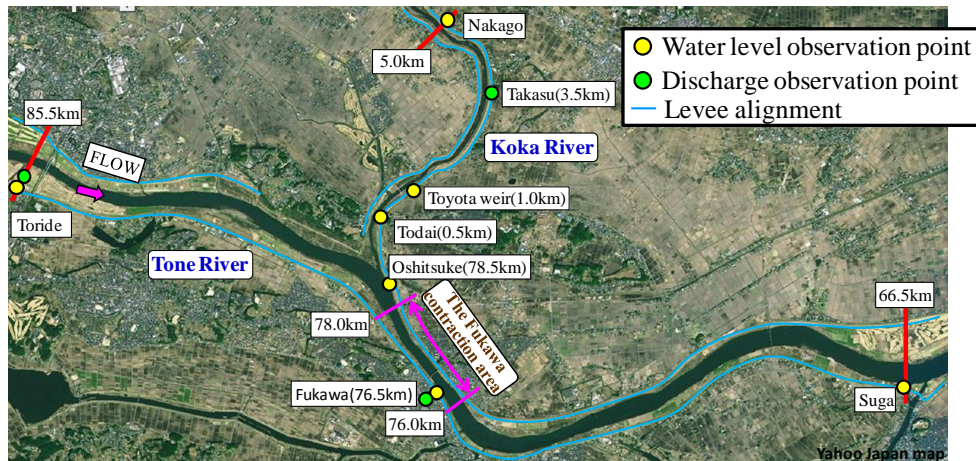
Figure 1 Study area and location of observation points in and around the Fukawa contraction area in the Lower Tone River.

Figure 1 shows study area and location of observation points in and around the Fukawa contraction area in the Lower Tone River. Figure 2 shows the maximum annual discharge at Toride (85.3km) and Fukawa (76.5km) observation point from 1962 to 2007, and the broken lines indicate the design high water discharge at the observation points. The dredging volume in the upstream and downstream of the Fukawa contraction area from 1972 to 2007 is shown in Figure 3. Since 1999, the dredging has not conducted in the upstream of the Fukawa contraction area and the dredging volume has been decreasing year by year in the downstream.

The initial bed forms were measured in 1980. The upstream and downstream boundary conditions were given by the time series data of observed water level at Toride (85.3km), Suga (66.5km) observation point in the lower Tone River and Nakago (5.0km) observation point in the Kokai river (See Figure 1). The mean grain diameter is 0.25mm in the study area. In the Fukawa contraction area, we assumed the river bed degradation does not occur at the place of diluvium in the analysis. Manning's roughness coefficients were set to 0.020 for the main channel and 0.038 for the flood channel.

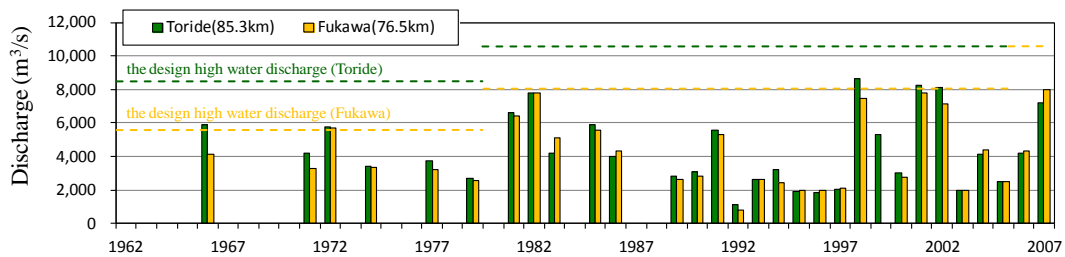
Figure 2 Maximum annual discharge.

After 1998, although the floods comparable to the design high water discharge have occurred (See Figure 2), the river bed elevation has not much degraded as shown by Figure 6 and Figure 7. There are two reasons for this. One is the decrease of dredging volume and the other is the geological factor in the Fukawa contraction area. Figure 9 shows the geologic cross section at 76.5km. The

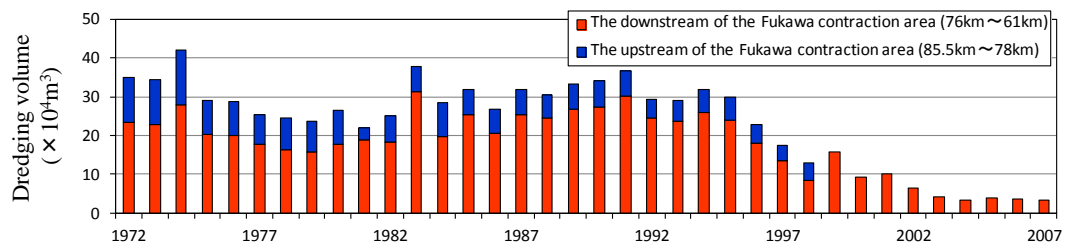
Figure 3 Dredging volumes in the upstream and downstream of the Fukawa contraction area.

From 1983 to 1998, the dredging has continued in the upstream and downstream as shown in Figure 3. And, the amount of the river bed degradation in the downstream is greater than in the upstream (See Figure 6 and Figure 7). Figure 8 shows cross sectional form at 76.5km after Sep.1983 and Sep.1998 flood, and broken lines indicate the peak water levels of the floods. Table 1 indicates the cross section area at the peak water levels. As shown in Figure 8 and Table 1, the water level in Sep.1998 flood is lower than in Sep.1983 flood. However, the cross section area in Sep.1998 flood is almost as large as in Sep.1983 flood. In the downstream of the Fukawa contraction area, because the river bed elevation decreased more greatly than in the upstream and the main channel has been widened, the water level has degraded. It is supposed that the scouring near the exit of the Fukawa contraction area progressed to get the almost same cross section area of Sep.1983 flood. From the above discussions, the dredging and widening in the downstream of the Fukawa contraction area are closely related to the river bed degradation near the exit of the Fukawa contraction area from 1983 to 1998.

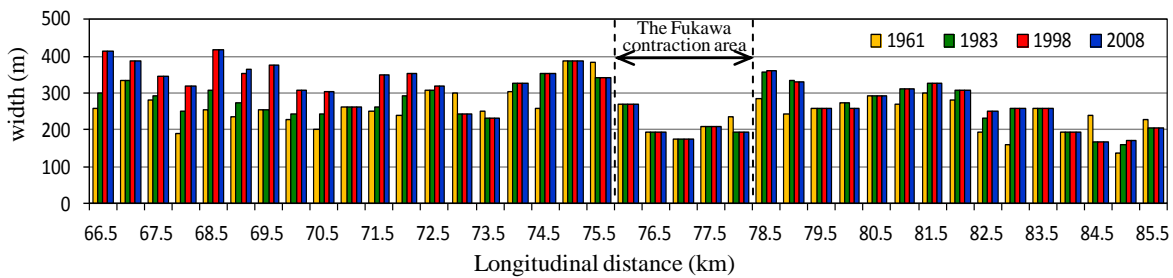
Figure 4 shows the changes in main channel width in the study area. Main channel has been widened longitudinally from 1961 to 1983 in the upstream and from 1961 to 1998 in the

Figure 4 Changes in main channel width.

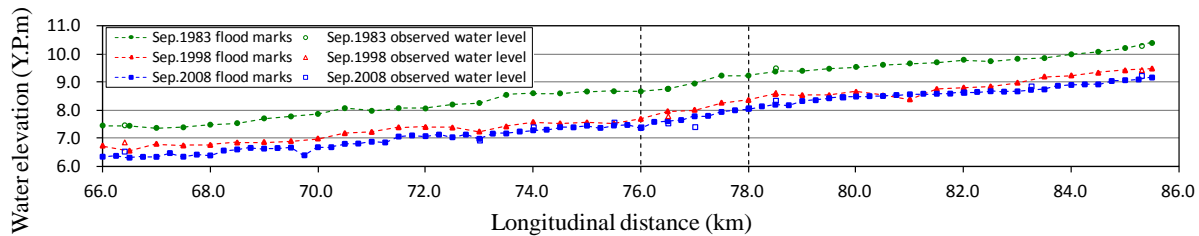
downstream for increasing the capacity of the river channel. In this area, large floods occurred at Sep.1983, Sep.1998 and Sep.2008. Figure 5 shows flood marks and observed maximum water level of each flood. Figure 6 and Figure 7 are the changes in average and deepest elevation of river bed in the study area. In the Fukawa contraction area, although the dredging has not conducted since 1966, the average and deepest river bed has greatly degraded from 1961 to 1983. On the other hand, from 1983 to 1998, the degradation of the river bed has caused mainly near the exit of the Fukawa contraction area (from 77.0km to 76.0km). And, the river bed elevation has not much degraded since 1998.

Figure 5 Flood marks and observed maximum water level of each flood.

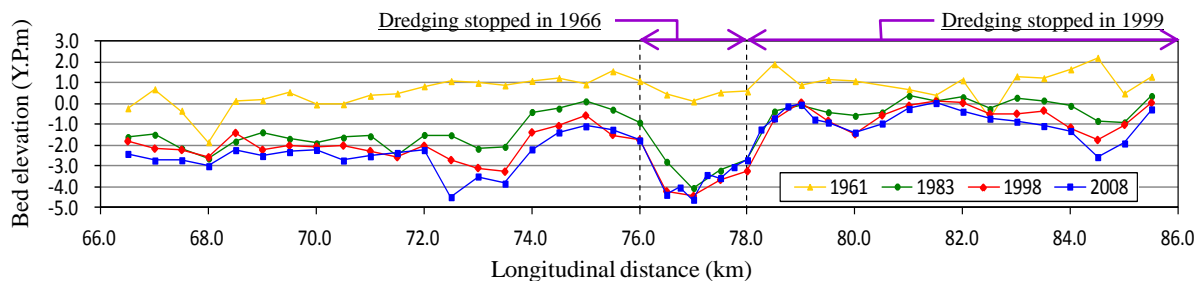
Figure 6 Changes in average elevation of river bed.

From 1961 to 1983, the dredging has been conducted actively in the upstream and downstream of the Fukawa contraction area. And, the amount of sediment from the upstream has reduced due to the erosion and sediment control management and the construction of dams in the upper Tone River in the 1960s. Therefore, the average and deepest elevation of river bed has degraded severely in the upstream and downstream of the Fukawa contraction area (See Figure 6 and Figure 7). And, the

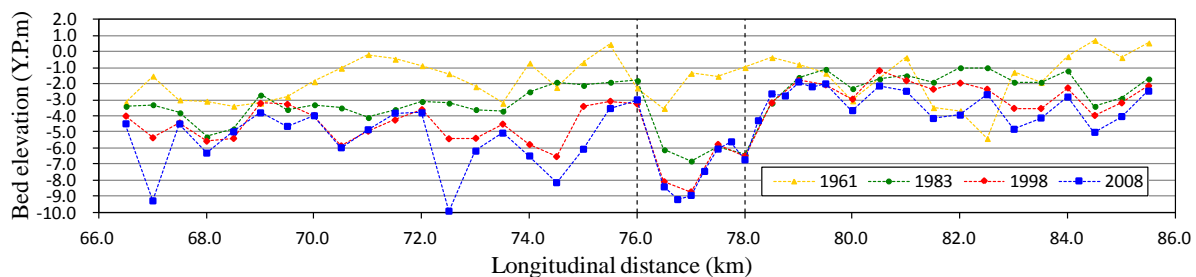
Figure 7 Changes in deepest elevation of river bed.

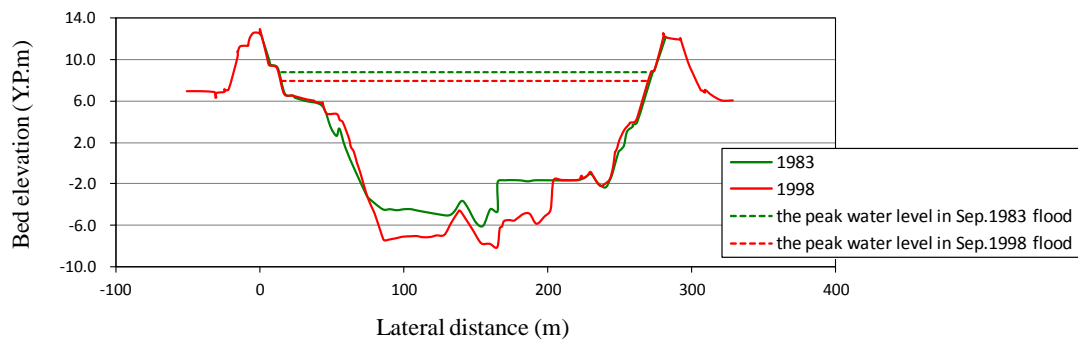
Figure 8 Peak water levels and cross sectional form at 76.5km.

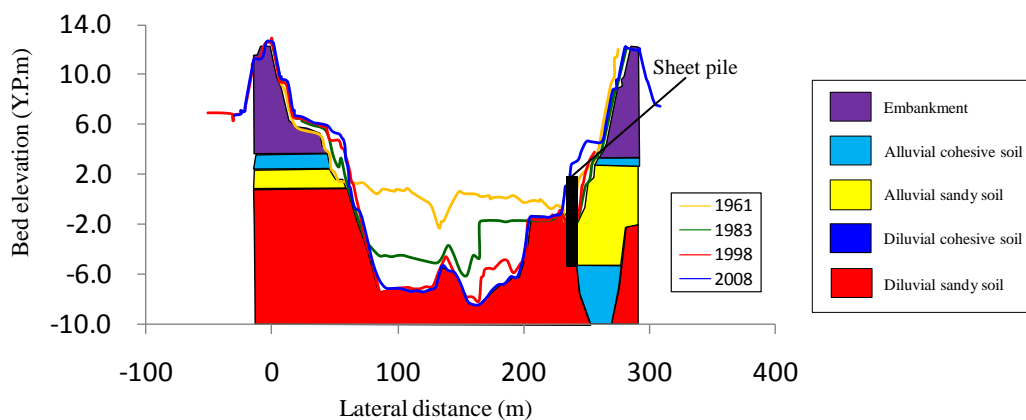
Figure 9 Geologic cross section at 76.5km.

geologic cross section indicates that the river bed surface has been covered with the diluvial sandy soil since 1998, which is more difficult to erosion than alluvium. For this reasons, it is considered that the river bed degradation near the exit of the Fukawa contraction area almost stopped.

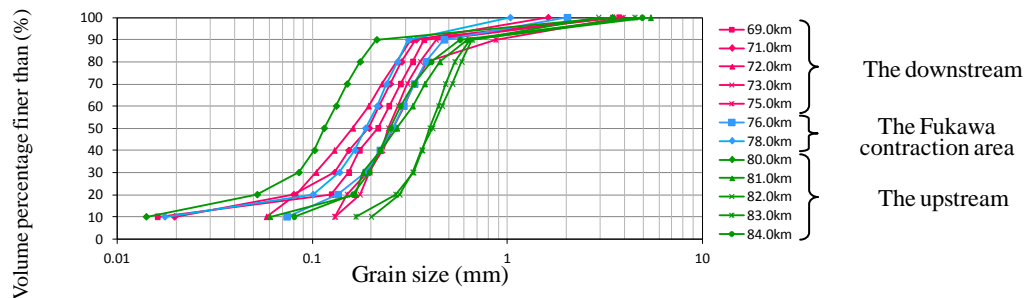
Figure 10 Grain size distribution in 1996.

The analysis consists the unsteady quasi 3-D flow (Uchida and Fukuoka, 2011) and bed variation analysis. The bed variation analysis was considered both bed load and suspended load because the grain diameter is relatively so small as shown in Figure 10 that the amount of suspended load is not negligible. The rate of bed load transport was calculated by Ashida and Michiue formula (Ashida and Michiue, 1972). The vertical distribution of suspended load concentration, fall velocity and amount of suspended load were calculated by using Lane-Kalinske formula (Lane and Kalinske, 1941), Rubey formula (Rubey, 1933) and Kishi-Itakura formula (Itakura and Kishi, 1980), respectively. The suspended load concentration was calculated by depth averaged planar 2-D convective diffusion equation.

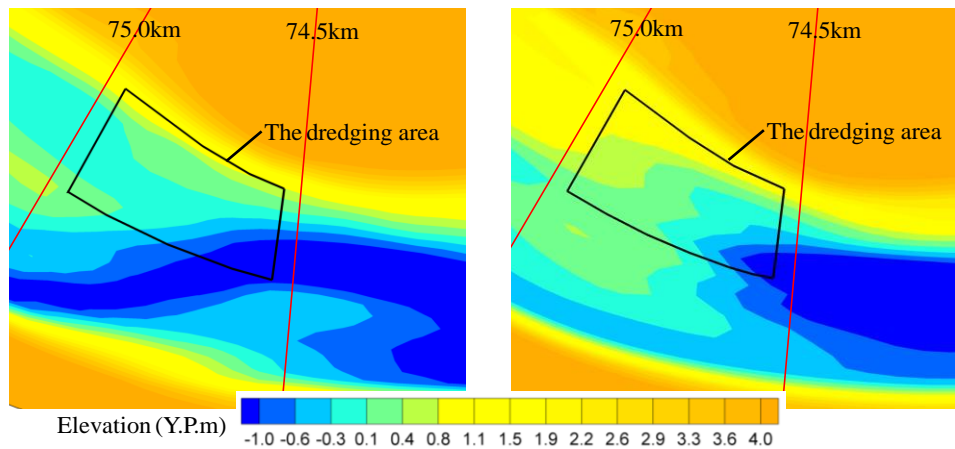
a) Observed river bed in 1983

b) Calculated river bed after the floods

Figure 11 Observed river bed contour in 1983 and calculated river bed contour after the floods.

Table 2 shows dredging range, dredging volume and implementation year. But, there was no data of dredging depth and area of each dredging location. We determined the dredging depth and area so that calculated bed profiles after the floods reproduce the observed bed profiles. Concretely, Figure 11 shows the observed river bed contour in 1983 and the calculated river bed contour after the floods and the area enclosed by black line indicates the determined channel dredging area. The channel dredging depth and area is estimated to correspond with the dredging volume in the location which the calculated river bed elevation is higher than the observed river bed elevation. If the calculated bed profiles after the floods do not sufficiently reproduce the observed bed profiles, we adjust the channel dredging depth and area by trial and error so that the calculated bed profiles reproduce the observed bed profiles.

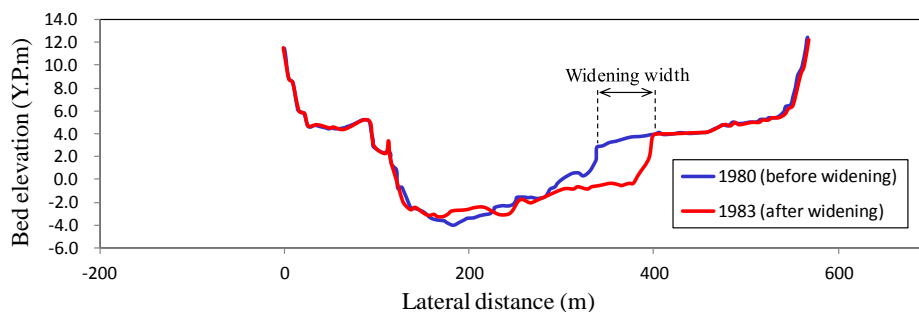
Figure 12 Cross sectional form before and after the river widening at 72.5km.

In the study area, the widening place name, kilometer post and implementation year have been recorded as shown in Table 3. But, widening area has not been recorded. In order to determine the widening area, we used the observed cross sectional form before and after the floods and the data shown in Table 3. First, we set the widening depth by comparing the cross sectional forms every point which cross-sectional leveling was conducted (e.g., Figure 12). From this, the planar area of channel widening is determined as indicated in Figure 13.

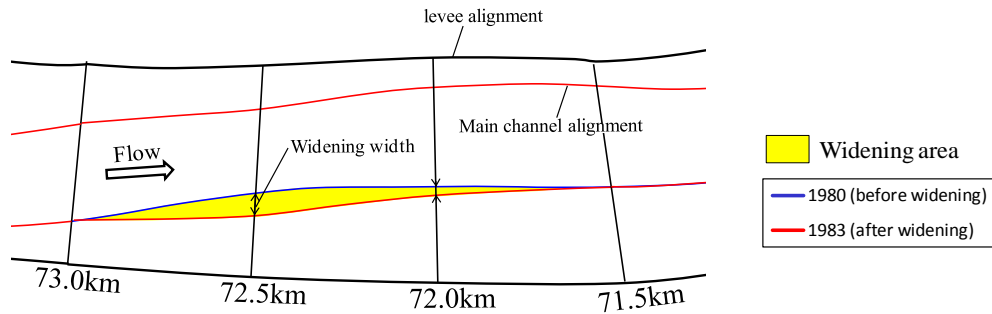
Figure 13 Planar change in main channel width from 1981 to 1983.

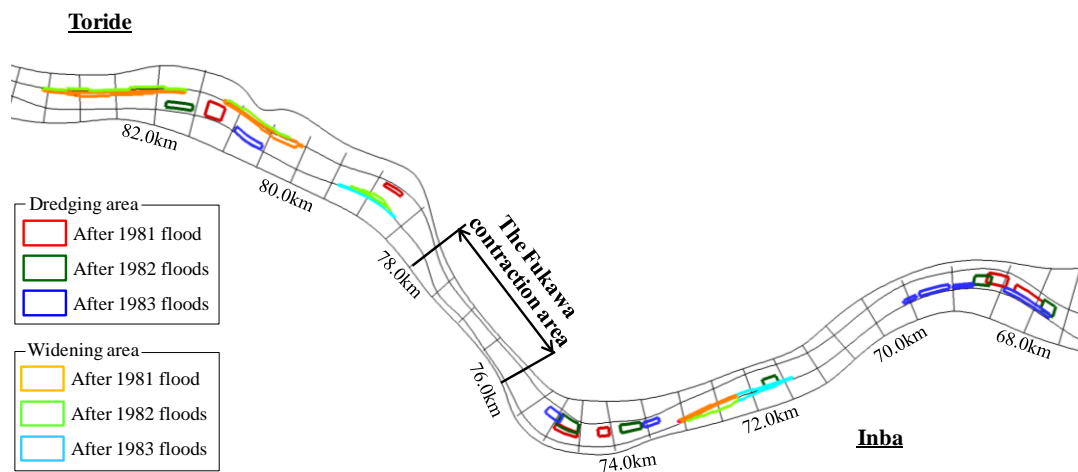
Conclusively, we set the planar area of channel dredging and widening of each year as shown in figure 14.

Figure 14 Planar area of channel dredging and widening of each year.

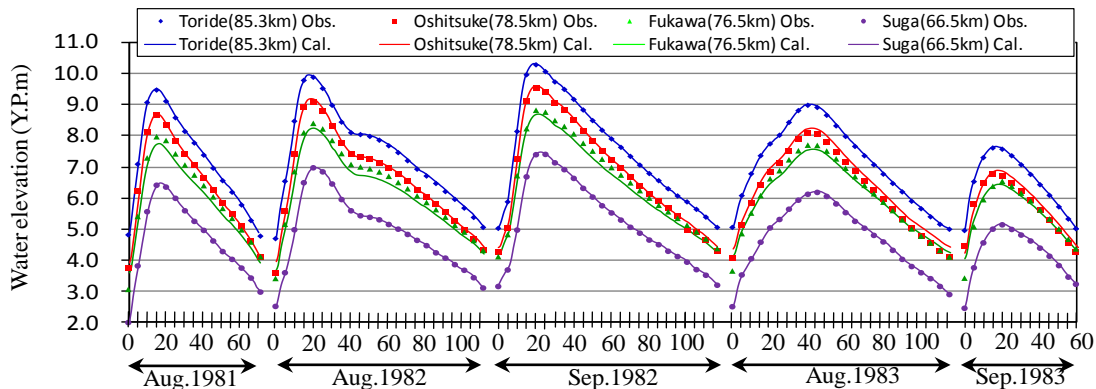
Figure 15 Comparison between observed and calculated water level hydrographs of the floods in the Tone River.

Figure 15 shows the comparison between observed and calculated water level hydrographs of the floods in Tone River. Figure 16 shows the comparison between observed and calculated discharge hydrographs of the floods in the Tone River and the Kokai River. The calculated water level and discharge hydrographs correspond well with the observed water level and discharge hydrographs.

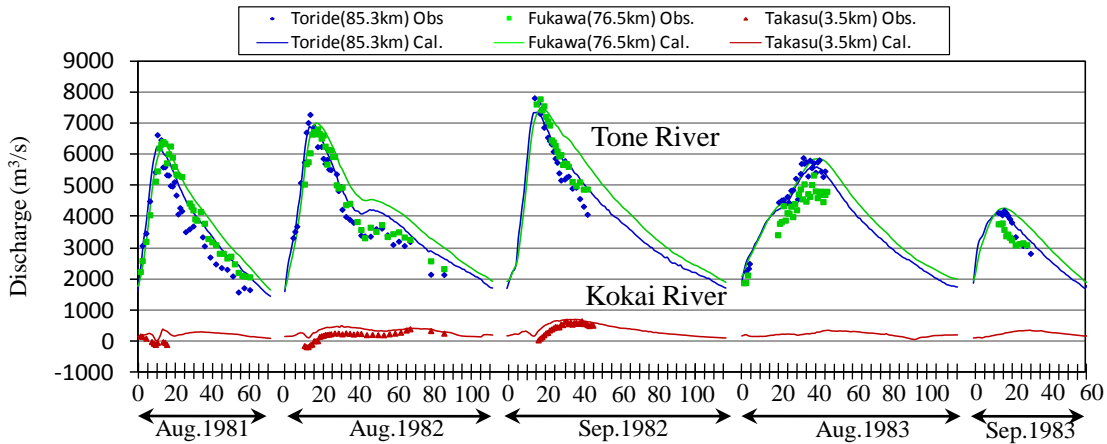
Figure 16 Comparison between observed and calculated discharge hydrographs of the floods in the Tone River and the Kokai River.

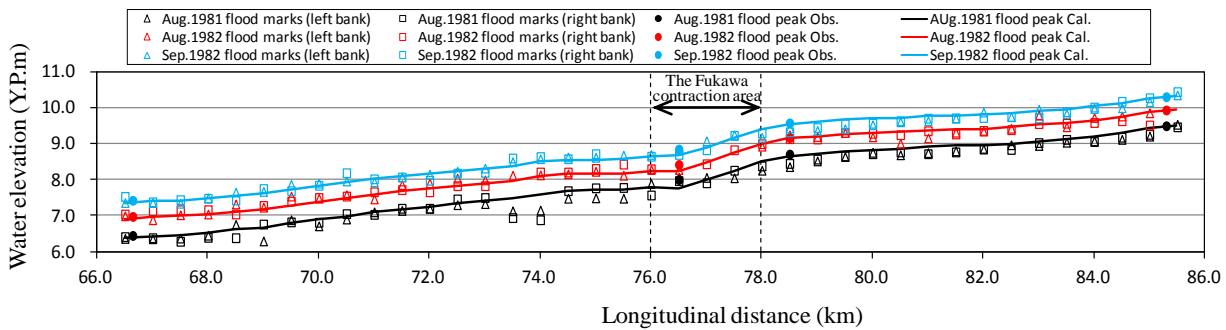
Figure 17 Comparison between observed and calculated water surface profiles at the peak of each flood.

Figure 17 is the comparison between observed and calculated water surface profiles at the peak of each flood. The calculation coincides with observed water surface profiles. Figure 18 shows the comparison between observed and calculated river bed elevation before and after the floods. The numerical computation provided a good explanation for the observed bed elevation after the floods.

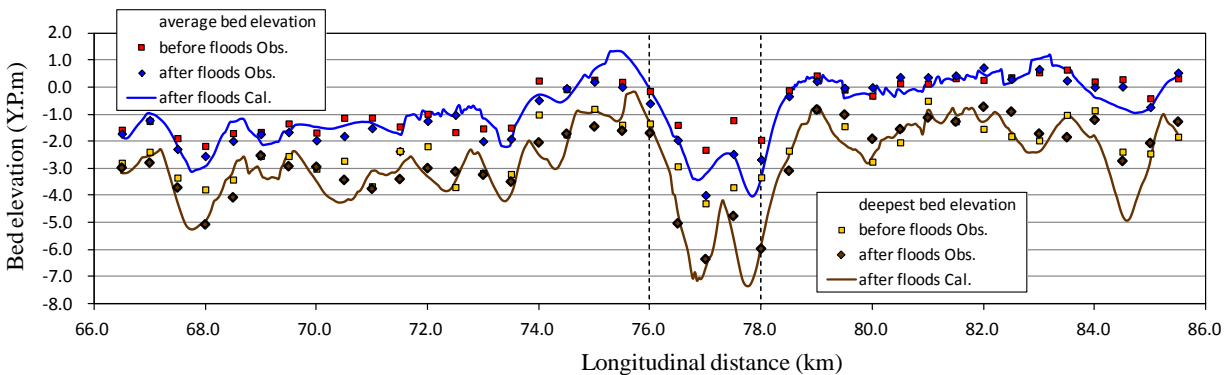
Figure 18 Comparison between observed and calculated river bed elevation before and after the floods.

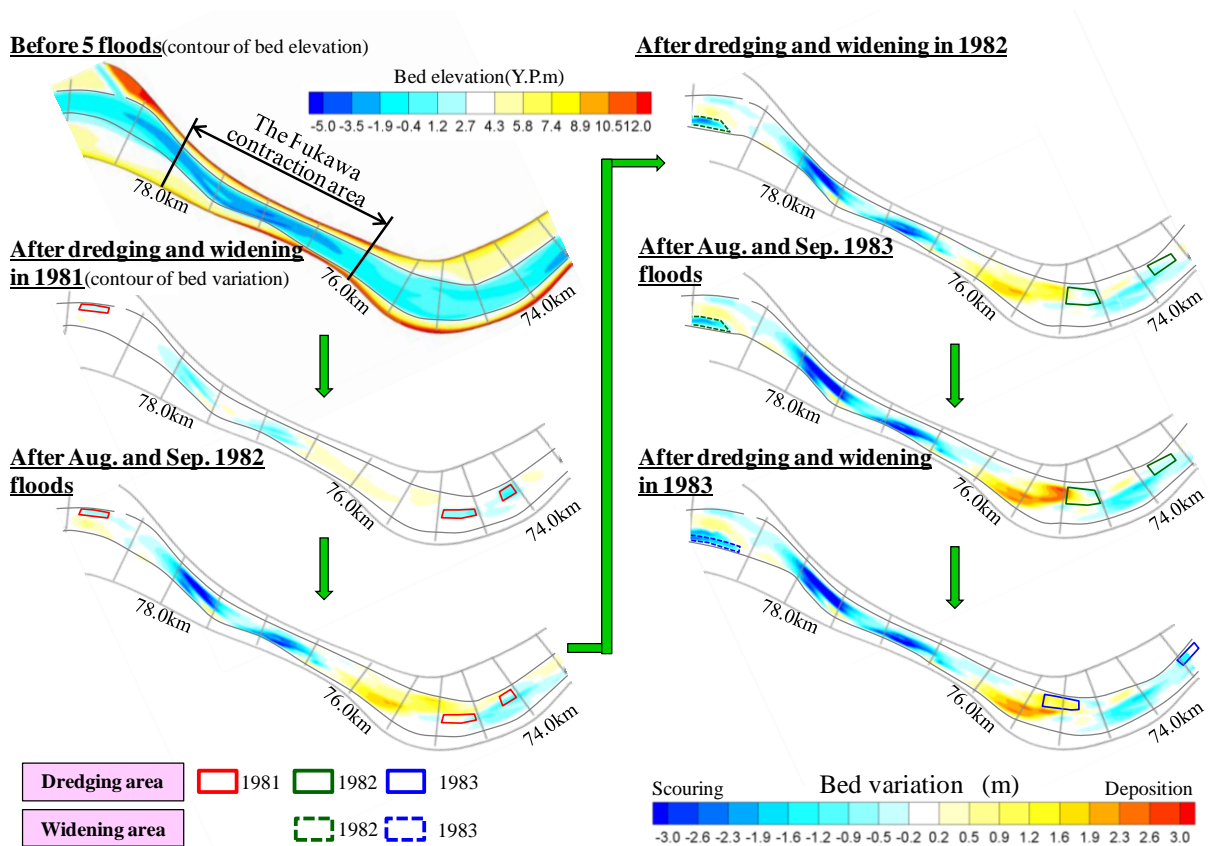
Figure 19 Calculated bed variation contour in and around the Fukawa contraction area from 1981 to 1983.

As a result, we reproduced the bed variation in and around the Fukawa contraction area from 1981 to 1983 by using numerical analysis as shown in Figure 19. The more the floods occurred, the more bed scouring progressed at the Fukawa contraction area and sediment deposition became noticeable at the exit of the Fukawa contraction area. Channel dredging was conducted around the location in which sediment deposition was considerable at the end of the contraction area. However, sediment deposition occurred again at the dredging location after the flood, in each year. In this way, we think that respective influences of channel dredging, widening and flood flows on change in river channel morphology can be analyzed by this method.
