Study on Flushing Mechanism of Dam Reservoir Sedimentation and Recovery of Riffle-Pool in Downstream Reach by a Flushing Bypass Tunnel

In the Asahi River, riffles and pools had been scaled down in the downstream reach of Asahi Dam due to sediment deposition in Asahi Dam reservoir. To improve this environmental problem, a flushing sediment tunnel was constructed so as to bypass Asahi Dam reservoir. In this study, first, the authors demonstrated the recovery of riffles and pools and the grain size distribution in the downstream reach by using the data of cross-sectional surveying, air photographs and field investigation. Next, authors' two-dimensional model was applied to a series of flood events in the Asahi River. As a result, the flushing mechanism of Asahi Dam reservoir sedimentation, the recovery process of riffles and pools and the change in grain size distribution in the downstream reach were clarified by the model.

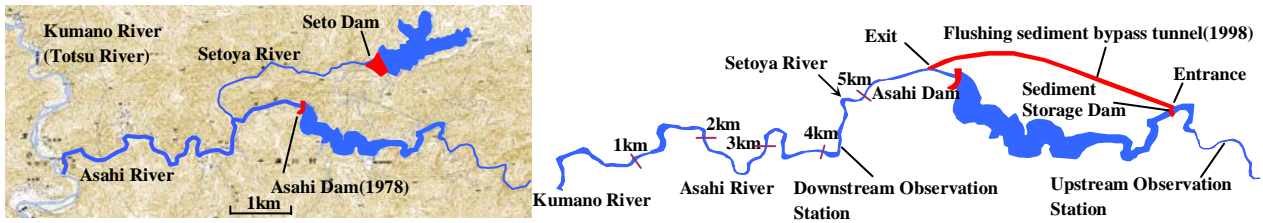
Figure 1. (Left) Asahi River Basin (Right) Plan View of the Flushing Bypass Tunnel

Figure 1 shows the Asahi River basin and the flushing bypass tunnel of Asahi Dam. Asahi dam has been

in Fig. 1(Right). Cross-sectional forms observed in 1998 were used to the initial form for the computation. The numerical model was applied to floods occurred from 1999 to 2003. Water level and discharge have been measured at observation stations upstream and downstream of the dam. Discharges from the flushing bypass tunnel and gates of the dam have also been observed. The upstream boundary condition was given by observed discharge hydrographs, and the downstream boundary condition given the uniform flow depth because water level had not been observed near the downstream end. Figure 9 shows computational grids at the area of the entrance and exit. To take into account the shape of the entrance and exit, the computational grid was developed more in detail than that of other area. The resistance of the orifice constructed at the entrance was given by the drag force so as to minimize difference between observed and calculated discharge hydrographs through the bypass tunnel. Figure 10 shows the grain size distribution observed upstream and downstream of the dam. Initial grain size distribution used for calculation was determined based on observed data as shown in Fig. 10. Equilibrium sediment transport was given as the upstream boundary condition.

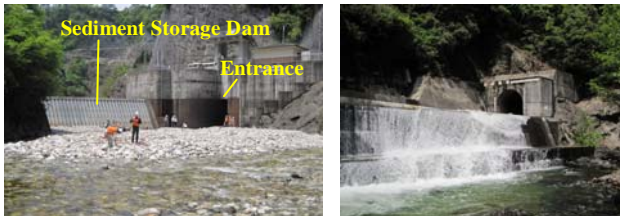
Figure 2. (Left) Entrance Viewed from Upstream (Right) Exit of Bypass Tunnel

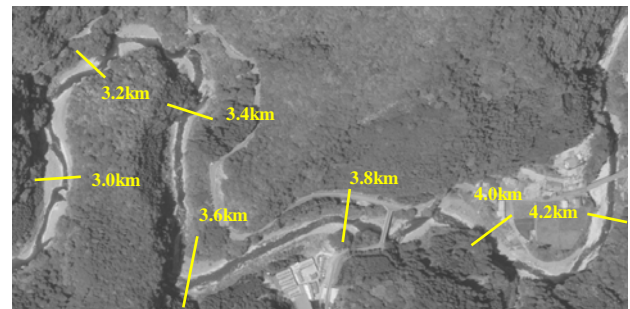
(a) May 1994

(b) May 2004

Figure 5. River Situation from 3.0km to 4.5km

Figures 4 and 5 show air photographs of the downstream reach taken before and after the construction of the flushing bypass tunnel (May 1994, May 2004). Figure 4 shows the channel situation just downstream of Asahi Dam. In 1994, the riverbed are visible to gray, and white

Figure 8 shows riverbed variation from bed elevation measured in 1998. Figure 8(c) corresponds to the situation of Fig. 4(b) and Fig. 5(b) taken May 2004. Flood peak discharges beyond $250\text{m}^3/\text{s}$ in 2001 and 2003 seem to cause larger riverbed variation and riverbed degrades from 3.8km to 5.0km and aggrades downstream of 3.8km.

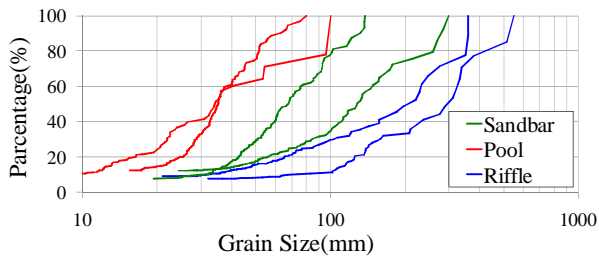
Figure 7. Grain Size Distributions of Sandbar, Riffle and Pool

size are smaller than that of sandbars and riffles. From the result of the field investigation, bed materials at riffles have been composed of coarse sediments of the sedimentary rock, and white stones are not easily deposited there. In contrast, white stones are easily remained in pools.

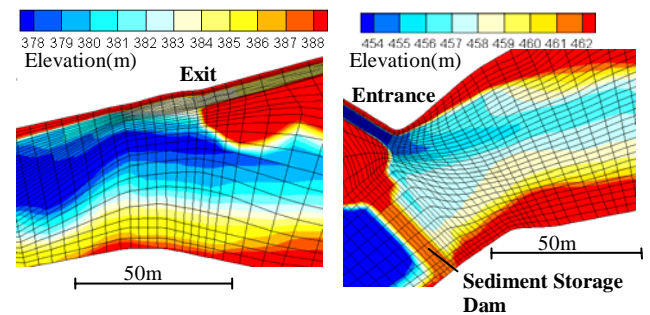
Figure 9. Computational Grid (Left)Exit (Right)Entrance

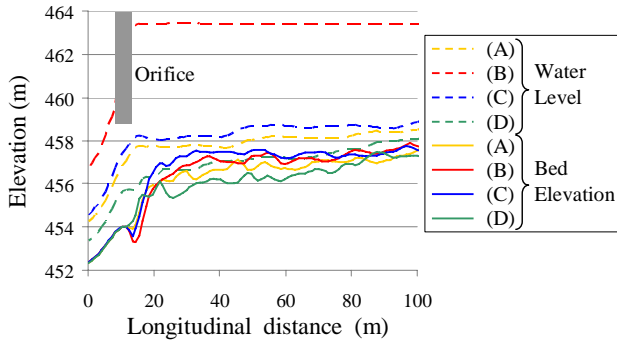
Figure 13. Variation of Water Level, Bed Elevation, Second Flood in 2001 ((A)-(D) correspond to the times indicated in Fig. 11.)

variation in the upstream of the entrance during the second flood in 2001. Figure 13 shows longitudinal water level and riverbed elevation profiles upstream of the entrance each time ((A)~(D)) shown in Fig. 11. Time in Fig. 13(B) displays as orifice flow. The water level upstream of the entrance was nearly constant and stones and gravel were not transported near the entrance but deposited in the sediment storage reservoir. At the time (C), water surface slope varied to the steep slope, and sediment deposited upstream entrance was transported to the entrance. Riverbed elevation profile at that time is shown in Fig. 12(b). In the time between (C) and (D), the water surface profile just upstream of the entrance was steep, then, large amount of stones and gravel deposited

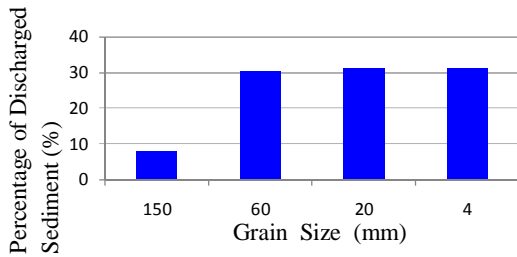
Figure 14. Percentage of Each Grain Size in Discharged Sediments

was discharged from the bypass tunnel. Then, bed elevation profiles varied from Fig. 12(b) to Fig. 12(c). The riverbed elevation profile upstream of the entrance was almost the same before and after the floods. It demonstrates that the flushing bypass tunnel displays a good performance. Figure 14 shows the percentage of each grain size in discharged sediments. The stone-class material of 150mm of 8%, and the other grain sizes of 30% were contained in them. These percentages are almost the same as the grain size distribution of initial condition upstream of the dam, thus each grain size group upstream of the dam were properly transported in the downstream river.

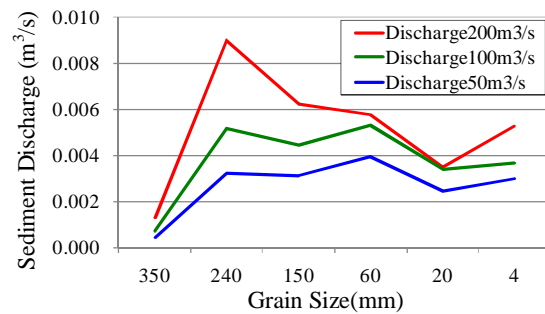
Figure 16. Sediment Discharge of Each Grain Size Associated with change in Flow Conditions

different flow conditions. These data are the calculated results averaged from 3.0km to 4.0km sections. When the discharge is $200\text{m}^3/\text{s}$, stone-class materials ($d > 75\text{mm}$) are actively transported in comparison with gravel-class materials, and large stones such as rolling stones ($d=240\text{mm}, 340\text{mm}$) can also be transported. When the peak discharge was larger than $200\text{m}^3/\text{s}$, outflow discharge is limited by $100\text{m}^3/\text{s}$ to regulate the water level in the reservoir as shown in Fig. 11. Sediment transport rate in $100\text{m}^3/\text{s}$ was less than that in $200\text{m}^3/\text{s}$. However, the grain size group from 240mm to 60mm were actively transported as shown in Fig. 16. White stone materials ($d < 150\text{mm}$) can be transported enough by $100\text{m}^3/\text{s}$. In case of $50\text{m}^3/\text{s}$, 60mm gravel-class group was mainly transported.

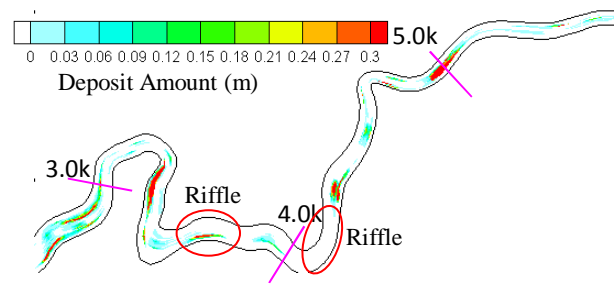
Figure 18. Distribution height of Sediment Deposition, 1999~2003

Figure 18 shows the distribution height of the sediment deposition discharged through the flushing bypass tunnel from 1999 to 2003. Figure 19 shows distribution of calculated mean grain diameter after 2003 floods. Since the initial condition of mean grain diameter was 160mm, the blue colours indicate grain size reduction and red colours armouring. Flushing sediments deposited mainly around 5.0km and in the downstream reach of 3.6km. Figure 5(b) shows that a large amount of depositing white stones is found in the downstream reach of 3.6km. The discharged sediment through the bypass tunnel until 2003 had been mainly deposited in this reach. It is considered that the sediments tend to deposit around 5.0km because river bed slope changes around this reach. Although sandbars by the deposition of white stones around 5.2km had been formed, the calculation could not describe it. The calculated result of mean grain diameter distribution downstream of 3.6km except for few points demonstrates grain size reduction due to deposition of white stones. On the other hand, white stones are hardly seen in riffles (e.g. around 4.2km and 3.7km) as shown by red circles in Fig. 18. Since white stone was not also

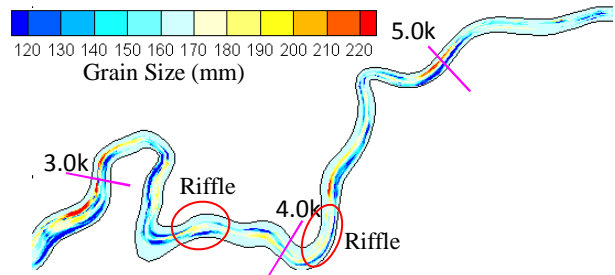
Figure 19. Distribution of Calculated Mean Grain Diameter, 2003
