River management viewed from long-term changes of the main channel in the middle reach of Tama River

Abstract. In the middle reach of Tama River, past massive gravel-excavations and construction of fixed weirs have caused lack of sediment transport and degradation of the river bed, resulting in the reduction of channel reaches with characteristic sandbars. We investigated the long-term change in the river channel by the observed data from 1947 to 2019 and evaluated the Tama River management up to now. Analysis showed that effects of river improvement works and foundation height of cross-structures were seen in the response of the main channel to floods. The height of river bed has been maintained by the cross-structures such as bed protection works, reconstructed weirs and the groundsills installed at proper longitudinal intervals. This brought sediment supply to river bed by the increase in the main channel width, and resulted in stabilization of the main channel, recovery of channel with characteristic sandbars. Considering the main channel bed stability based on long-term river channel change leads to effective river management in harmony with flood control and river environmen

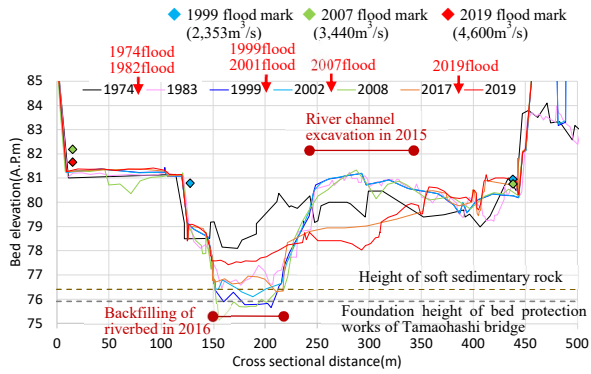
(a) 43.8km(directly upstream of the Tamaohashi bridge)

Figure 5: Annual changes in cross-sectional profiles.

Therefore, river improvement works has been implemented in the section upstream and downstream of the Tamaohashi bridge (44.8 to 43.4km) from 2014 to 2016, including backfilling of gravels to the degradation reach, 60 excavation of immobilized sandbars, and installation of ground sills at the certain interval to maintain the river bed level (Ozawa et.al., 2013 and Ohnami et.al., 2021). In 2019 large flood, the concentration of flood flows to the main channel was alleviated and the main channel bed 65 level between ground sills is mostly free from the degradation as in Figure 3. These works created the stable main channel and contributed to recover the channel with sandbars around 1970s as in Figure 1(d) and Figure 5(a), which was the main target of river improvement works of 70 the Tama River.

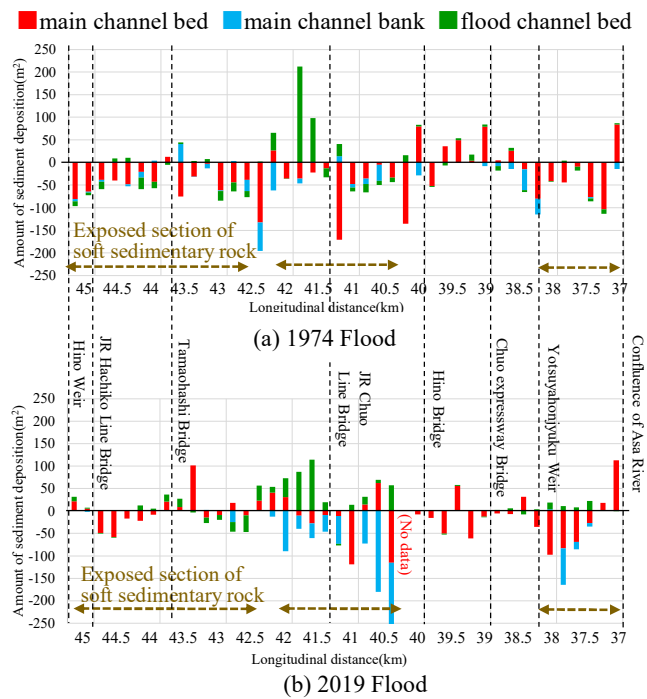
Figure 6: Longitudinal distribution of sediment deposition and erosion due to floods.
