River improvement techniques for mitigating river bed degradation and channel width reduction in the sandy Hii River where sediment transport occurs at normal times

Abstract. In the sandy Hii River, a large amount of sediment yield from upper river basin had brought developments of braided channels covered with sand waves. In the braided channels, sediment materials on the river beds are capable to move in normal discharge conditions. In recent years, however, the sediment yield decreases due to constructions of check dams and ground sills in the upper river basin. Thus, the river beds downstream of the ground sill have gradually degraded and the main channel widths have been narrowed with the progressing bed degradation. Firstly, we clarified that the effects of non-equilibrium sediment transports around the ground sill during normal discharge conditions on the bed degradation and the channel width reduction by using annual observed data and numerical simulations for bed variations. In addition, we provided the river improvement techniques for mitigating bed degradation and channel width reduction by improving state of non-equilibrium sediment transports passing through the groun

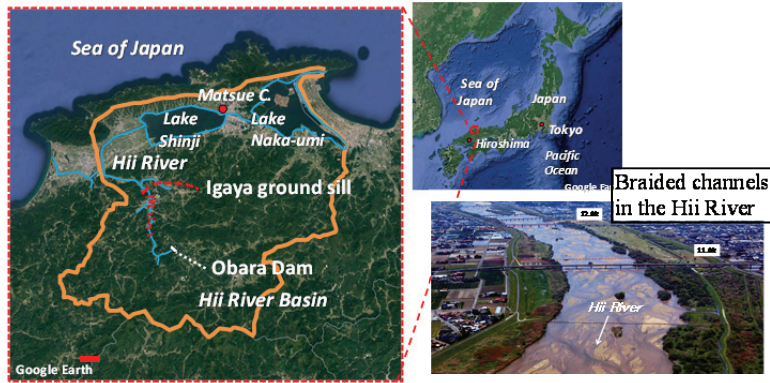
Fig. 1. Location of the Hii River and the braided channels in the river.

The Hii River is located at Shimane prefecture in Japan and flows into the Sea of Japan through the Lake Sinji and the Lake Naka-umi (see Figure 1). The upper basin of the Hii River had yielded a large amount of sediment composed of fine sand materials. It had caused great aggradation of the river bed in the lower Hii River until 1960s. Due to the bed aggradation, the bed elevations of the main channel in the lower Hii River have raised than the ground level of the urban area along the river. And it has brought flood inundation disasters around this area in the past years.

Meanwhile, a large amount of fine sediment yield has formed braided channels which are covered with well developed sand waves. The braided channels in the lower Hii River (around 11.0km) at the normal discharge conditions are shown in Figure 1. In the braided channels, sediment materials on the river bed are capable to move due to normal discharge flows since the river bed materials are almost uniform sizes of fine sands which are approximately 1mm to 2mm in diameter. Figure 2 shows ratio of shear stresses to the critical shear stress in the braided river section (12.4km) during the normal discharge

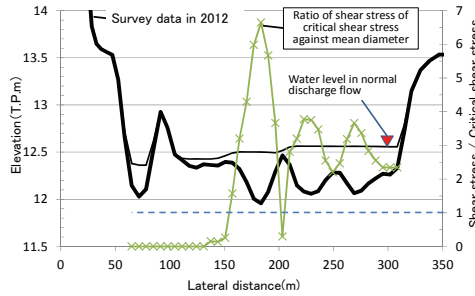
Fig. 2. Ratio of shear stress to critical shear stress in the braided river section.

condition. Here, the normal discharge in this section is approximately $50\text{m}^3/\text{s}$ by the annual observation records. The ratio of shear stresses to the critical shear stress indicates to be about 3 to 5 times at the cross-section.

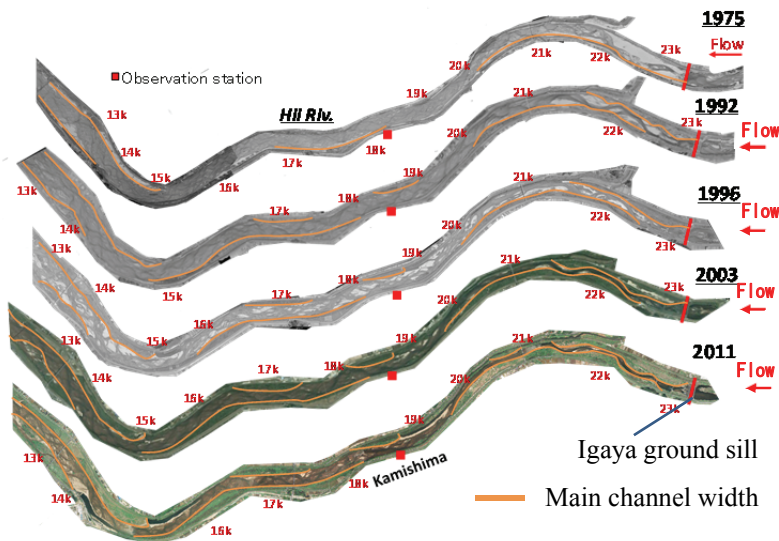
Fig. 3. Annual changes in main channel width in the Hii River.

Figure 3 shows the aerial photographs and the changes in the main channel widths since 1975 until 2011. Here, the main channel widths shown in Figure 3 were determined by using the cross sectional shapes (see Figure 4). Figure 4 shows cross sectional shapes at

17.0km and 18.6km in the periods. In 1975, the braided channels were formed across the full river width defined by widths between the levees. However, since 1992, the reduction of the main channel widths has begun and gradually progressed toward the downstream from the Igaya ground sill which was installed at 23.3km. Figure 5 indicates the annual changes in the observed mean bed elevations of the main channel. Due to the reductions of the main channel width, the mean bed elevations in the main channel have gradually degraded from the Igaya ground sill toward the downstream. The bed degradation has reached around 14.4km point until 2011.

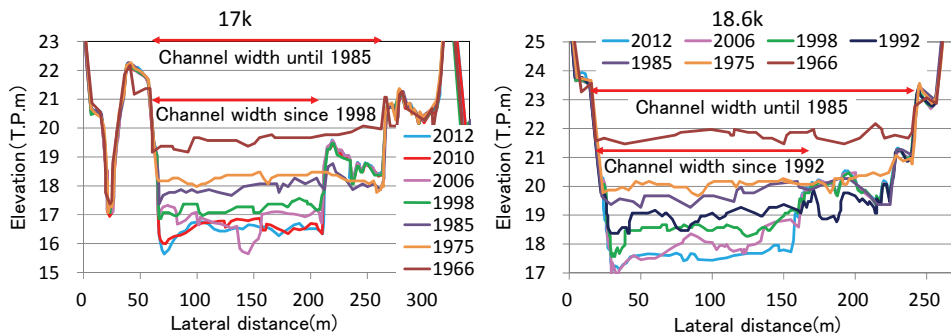
Fig. 4. Annual changes in cross sectional bed profiles and definition of main channel widths.

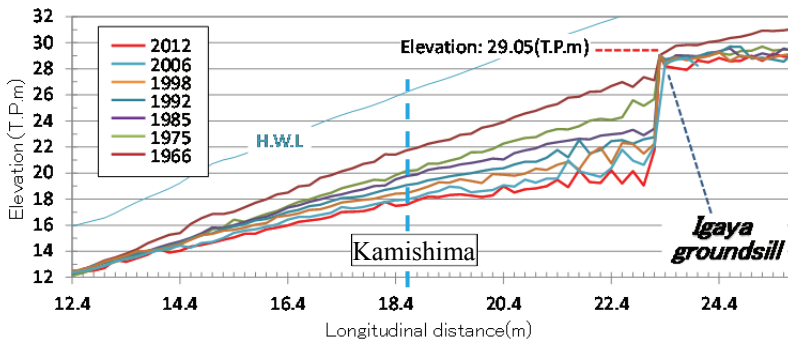
Fig. 5. Annual changes in longitudinal distributions of observed mean bed elevations in the main channel.

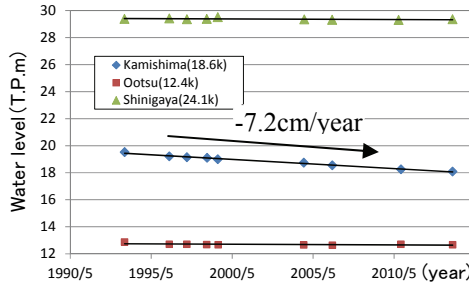
Fig.6. Annual changes in observed water levels in normal flow condition.

Figure 6 indicates the annual changes in observed water levels in the normal discharge at Kamishima observation station (18.6km) which is located about 5km downstream from the Igaya ground sill. The observed data shows that the water levels in the normal discharge have gradually declined with the river bed degradation. The declining of water levels per year since 1993 until 2011 is approximately -7.2cm. It seems to be almost independent from frequency and scale of the past flood events shown in Table 1. Table 1 indicates the history of main flood events in the past about 50 years. Figure 7 shows observed cross sectional shapes at upstream and downstream of the Igaya ground sill (23.4km, 23.0km). At the upstream section of the ground sill, the bed elevations of the main channel in recent years became lower than the elevation of the ground sill which was 29.05 T.P.m, T.P. :

Tokyo peil, Japanese datum of leveling. Therefore, the ground sill has prevented sediments transported from the upstream section during the normal discharge conditions and small scale floods. At the cross section of 23.0km downstream of the ground sill, the river bed in the main channel was scoured during the period from 2006 to 2010 although large scale floods did not occur in this period (see Table 1). It means that the river bed degradation has progressed due to effects of non-equilibrium sediment transports passing across the ground sill during the normal discharge conditions and small scale floods.

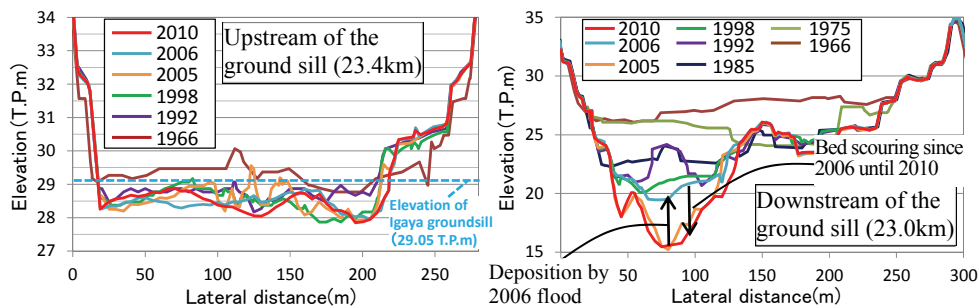
Fig. 7. Annual changes in observed cross sectional shapes of upstream and downstream of the Igaya ground sill (23.4km and 23km).

On the other hand, in large scale flood of 2006 flood, flood flows were able to transport sediment materials across the ground sill and the sediment materials were deposited downstream of the ground sill (see Figure 7). Therefore, we found that the sediment passing through the ground sill during large scale floods mitigated the bed degradation and the reduction of main channel widths in the downstream of the ground sill. It was found that improving the state of non-equilibrium sediment transports passing across the ground sill was important to mitigate the bed degradation and the channel width narrowing.

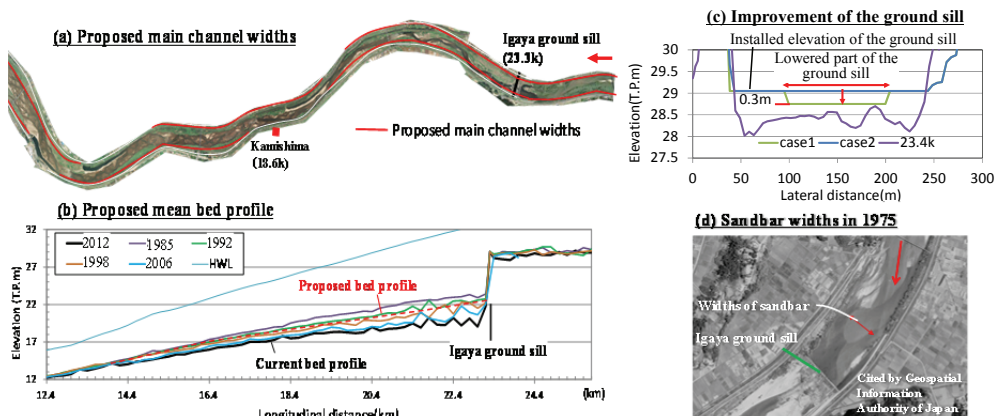
Fig. 8. River improvement techniques.

Figure 8(a) and (b) show the proposed main channel widths and the longitudinal mean bed elevations of the main channel. The main channel widths and the mean bed elevations were determined so as to agree with those in 1992 when the reduction of the main channel was not noticeable problems for the river managements. In addition, for increasing sediment replenishments from the upstream of the Igaya ground sill, we attempted to lower the elevation in the central part of the ground sill as shown in Figure 8(c). The width of the

lowered part of the ground sill was determined based on the width of sand bars in 1975 when the river bed profiles were relatively stable (see Figure 8(d)). The height of the lowered part of the ground sill was 0.3m. It was determined by taking into account elevations of sand bars at the upstream sections of the ground sill and elevations of water intake facilities upstream of it.

The simulation cases were as follows. In Case1, channel widths and bed elevations downstream of the ground sill were improved as described in Figure 8(a), (b) and the central part of the ground sill was lowered as shown in Figure 8(c). In Case2, channel shapes were same as Case1. But the elevation of the ground sill remained as the current conditions.

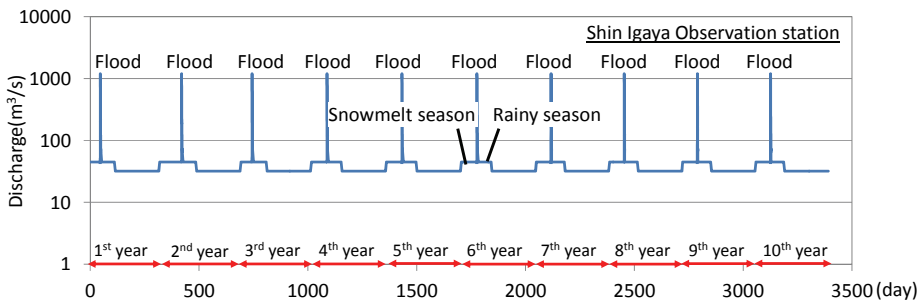
Fig.9. A series of discharge hydrographs given at the upstream end.

A series of discharge hydrographs based on the past observation records were given as the boundary conditions of upstream ends (see Figure 9). The normal discharge of rainy seasons and snowmelt seasons were considered in this simulation. The observed water level hydrograph in the Lake Shinji was given as boundary conditions of downstream end. Manning's roughness coefficient in the main channel was $0.027(\text{m}^{-1/3}\text{s})$ which was determined by using temporal changes in observed water surface profiles during 2013 flood in our previous studies[3] in the Hii River.

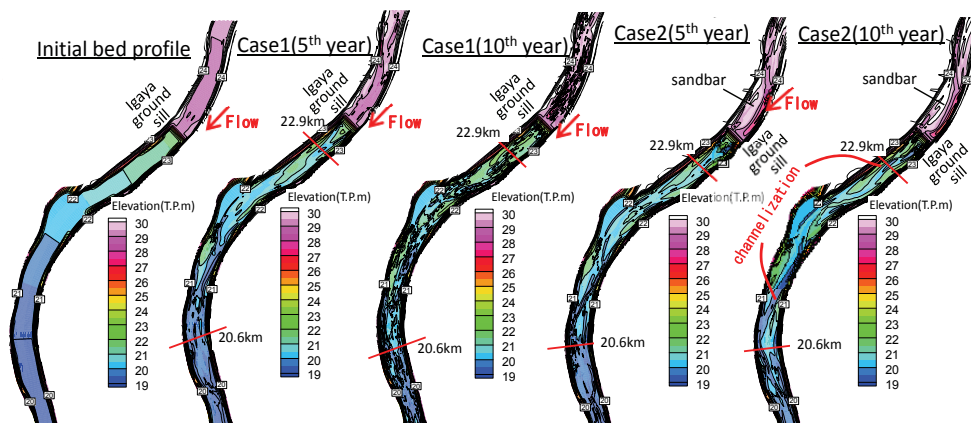
Fig.10. Contour of the initial and calculated bed profiles of Case1 and Case2.

Figure 10 shows the calculated contour of bed profiles downstream of the ground sill in each case. In Case2, the numerical results show that the bed profile downstream of the ground sill was obviously channelized due to the repetitions of flood flows and normal discharge flows. At the upstream section of the ground sill, the sand bar gradually developed and it gave rise to meandering pattern of the main channel in the downstream of the ground sill. On the other hand, by lowering elevation of the ground sill shown in Case1,

the normal discharge flows were able to transport sediment materials smoothly across the ground sill without sand bar developments at the upstream section. Hence, the channelized bed morphology did not form clearly in downstream section of the ground sill. Figure 11 shows calculated cross-sectional shape at 20.6km and 22.9km after the repetition of flood flows and normal discharge flows for 10 years period. In the calculation results of Case2 which formed channelized river bed morphology, the differences of bed elevations between main channel and sand bars became larger than those of Case1. And the maximum height of the differences was more than 2m.

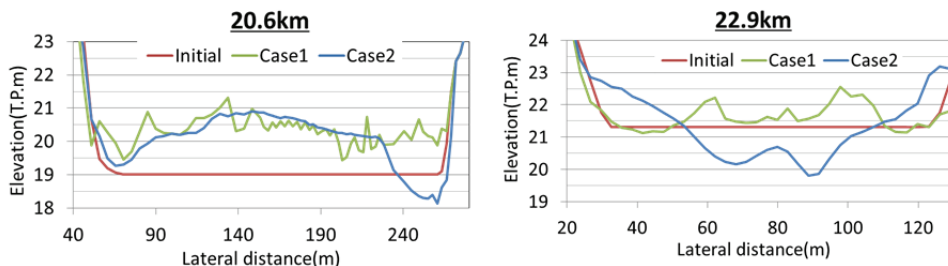
Fig.11. Calculated cross sectional bed profiles of Case1 and Case2.

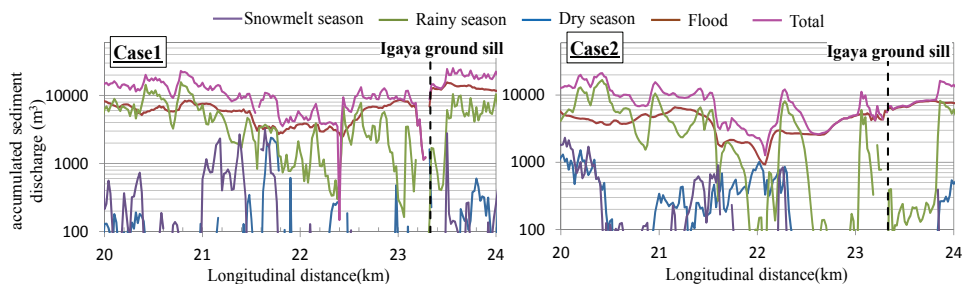
Fig.12. Longitudinal distributions of accumulated sediment discharge for a year in 10th year.

Figure 12 presents the calculated longitudinal distributions of accumulated sediment discharge during a year. The sediment discharge of Case2 rapidly decreased at the downstream of the Igaya ground sill. However, in the results of Case1, the sediment discharge at the downstream of the ground sill was increased by lowering elevation in the central part of the ground sill compared with Case2. The calculation results showed that the river improvement techniques of Case1 were able to mitigate the state of non-equilibrium sediment transports around the ground sill and channelization and channel incisions downstream of the ground sill.
